Letter Health Consultation

FORMER STELLA CARDWELL HOSPITAL
STELLA, NEWTON COUNTY, MISSOURI

MAY 22, 2008

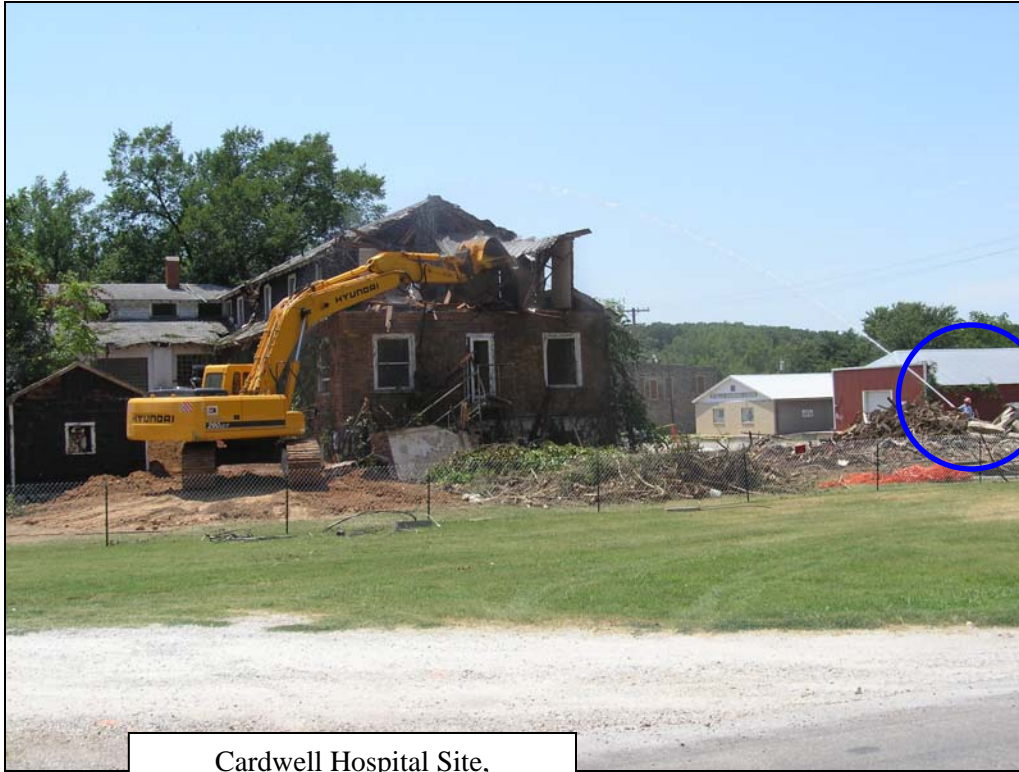
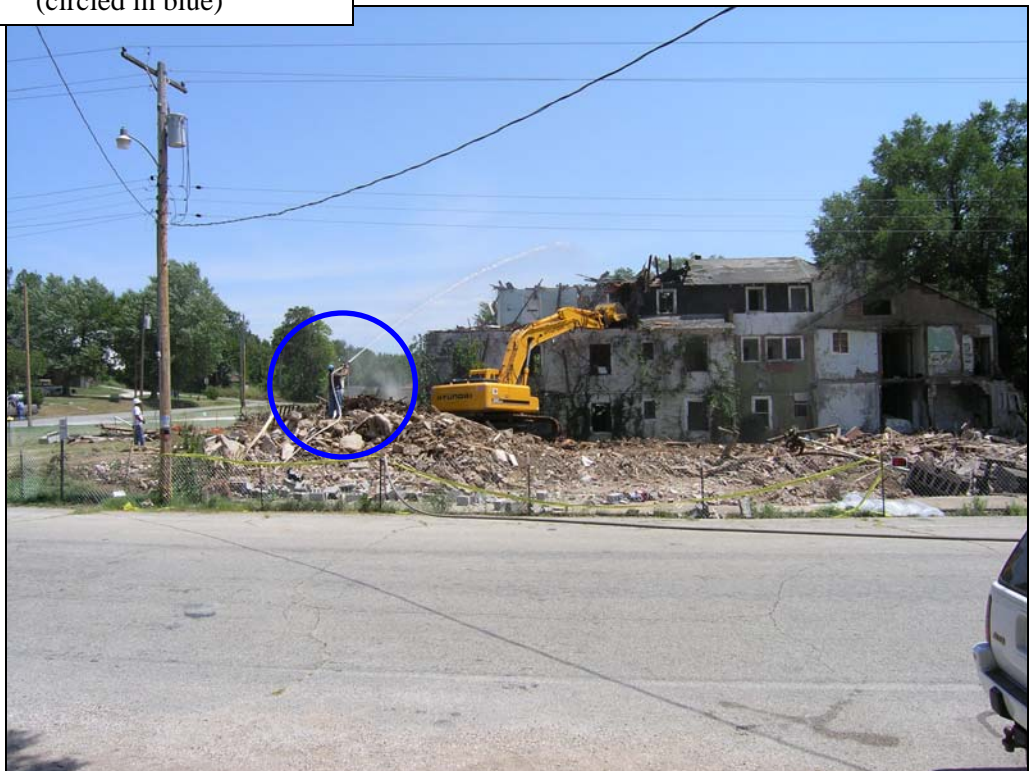
Figure 3
Cardwell Hospital Building Demolition, Dust Suppression
Cardwell Hospital Site
Stella, Missouri

Cardwell Hospital Site,
Dust suppression application.
(circled in blue)

The EPA contractors took several steps to ensure that asbestos fibers or dust contaminated with lead based paint were not released from the site above levels of health concern during the clean up actions. Removal of ACM inside the building was primarily conducted within four constructed plastic enclosures under negative air pressure to ensure that asbestos fibers were not released outside of the building. Non-friable transite siding was kept wet and was carefully removed from the exterior of the building to minimize breaking. For the portion of the building that was structurally unsound, EPA contractors employed a wet-demolition technique to keep air emissions to a minimum. Finally, as the remainder of the building was demolished, a water spray was continually used to suppress fugitive dust (3). See Figure 3.

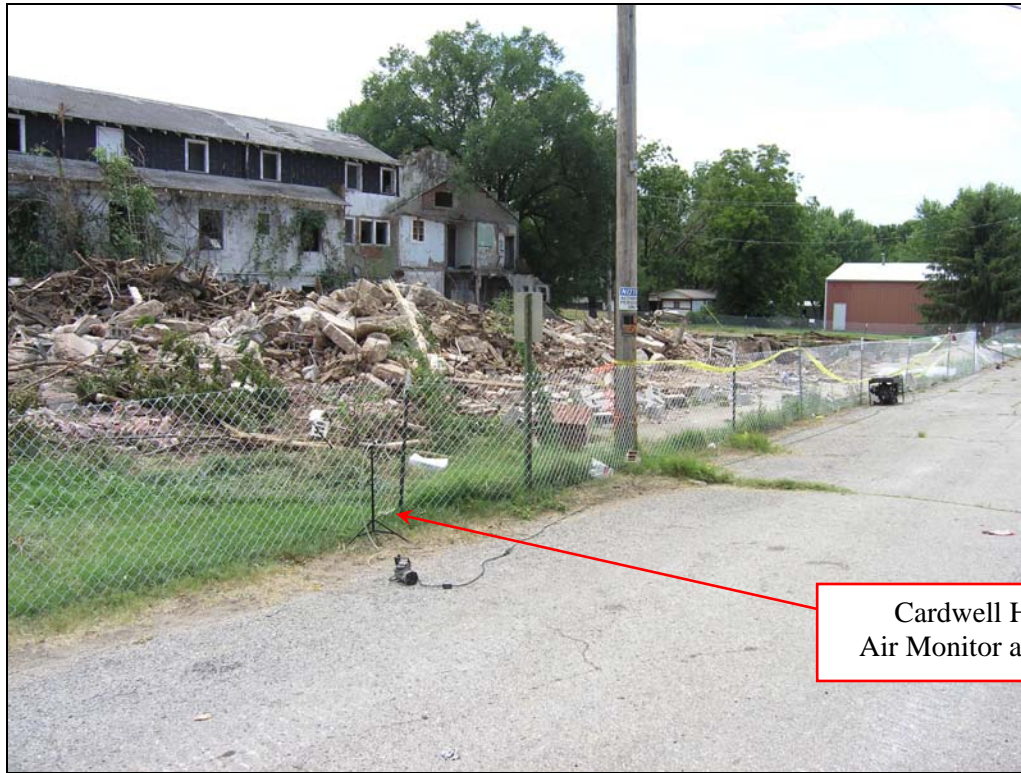
Figure 4
Cardwell Hospital Building Demolition, Perimeter Air Monitoring
Cardwell Hospital Site
Stella, Missouri

Cardwell Hospital Site,
Air Monitor at Site Perimeter

Cardwell Hospital Site,
Close Up View of Air Monitor

In addition to these removal techniques to prevent a release of asbestos fibers from the site, EPA contractors also conducted ambient air monitoring (Figure 4) to verify that asbestos or lead paint dust was not leaving the site above levels of health concern (3). The Occupational Safety and Health Administration (OSHA) has established a level of 0.1 fibers per cubic centimeter (f/cc) as the limit for workplace exposure to asbestos (2). EPA contractors took action to reduce asbestos levels in air if the concentration of asbestos rose above 0.01 f/cc (3). The EPA has established a residential health-based benchmark of 0.0009 f/cc in indoor air (4). However, this benchmark does not apply to the short exposure time potentially experienced by individuals at the former Cardwell Hospital site during clean up actions by EPA.

Air samples were collected during and after asbestos abatement activities and demolition of the building. A total of 9 air samples were collected at the perimeter of the site during asbestos abatement. The concentration of asbestos in one sample was reported by the laboratory as less than 0.03 f/cc, but all others were 0.01 f/cc or less. A total of 15 air samples were taken during asbestos abatement right at the work areas. The highest concentration of asbestos at these locations was one sample that showed 0.05 f/cc asbestos in air; the other sample results were 0.01 f/cc or lower. Finally, 18 air samples were also collected in areas of the building where abatement was complete to verify that asbestos did not remain in ambient air. Three of these samples were above 0.01 f/cc, including one sample at 0.21 f/cc. The remainder of the samples were all below 0.01 f/cc. The three samples above 0.01 f/cc were believed to be associated with removal of exterior asbestos-containing siding very near the interior sample collection point. Corresponding background air samples at the site perimeter that day showed asbestos levels of 0.004 f/cc or less, indicating that the exterior siding removal may have created localized elevations of asbestos concentrations, but did not contribute to significant levels of asbestos migrating off site (3).

Because of the presence of lead based paint throughout the building, ambient air dust samples were collected at the site perimeter throughout the demolition of the building. These samples were analyzed for lead to verify that lead was not leaving the site above levels of health concern. No lead was detected in any of the samples, although the laboratory method used to analyze the samples was not sensitive enough to detect very small levels of lead. Because the entire building demolition lasted only 19 days (from July 24th to August 11th), any exposure to lead in ambient air from this site is expected to have been below a level of health concern.
